**Methodology to determine the socioeconomic impact
and ecosystem services loss caused by ravines and
gullies**

Dissertation

der Mathematisch-Naturwissenschaftlichen Fakultät
der Eberhard Karls Universität Tübingen
zur Erlangung des Grades eines
Doktors der Naturwissenschaften
(Dr. rer. nat.)

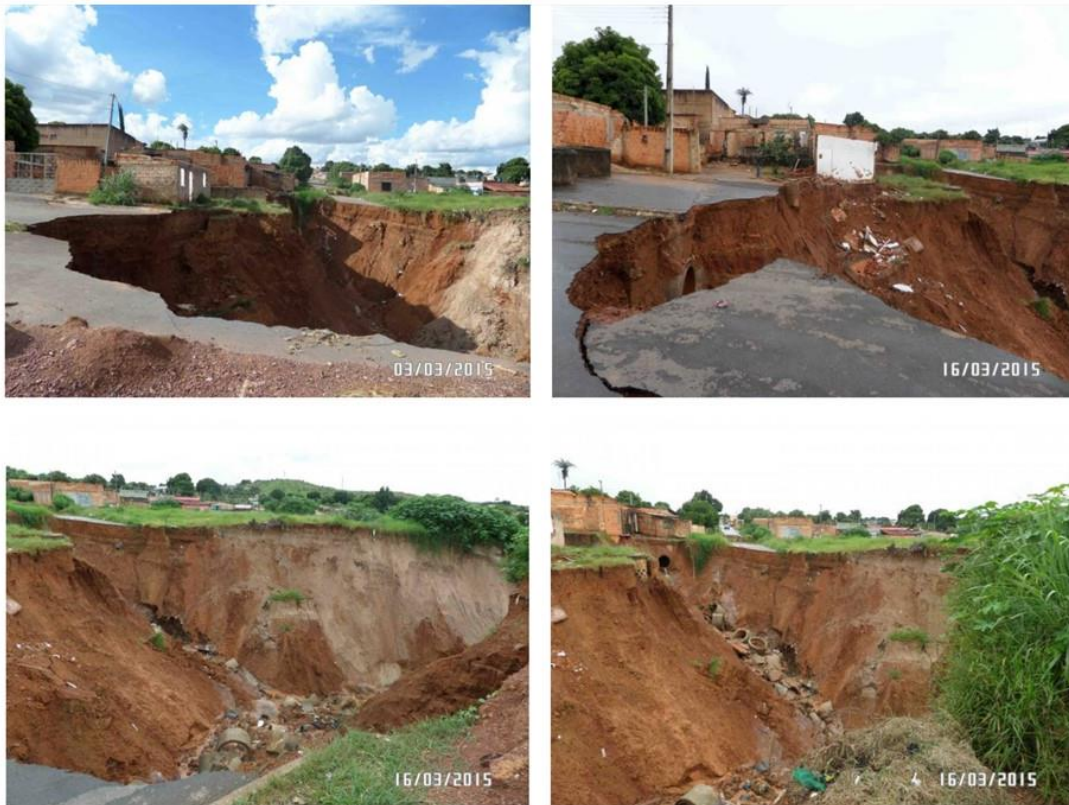
Figure 10. Destruction of public structures and residences in the municipality of Novo Gama, state of Goiás (Pimenta 2015). (Source: S2ID system reports).

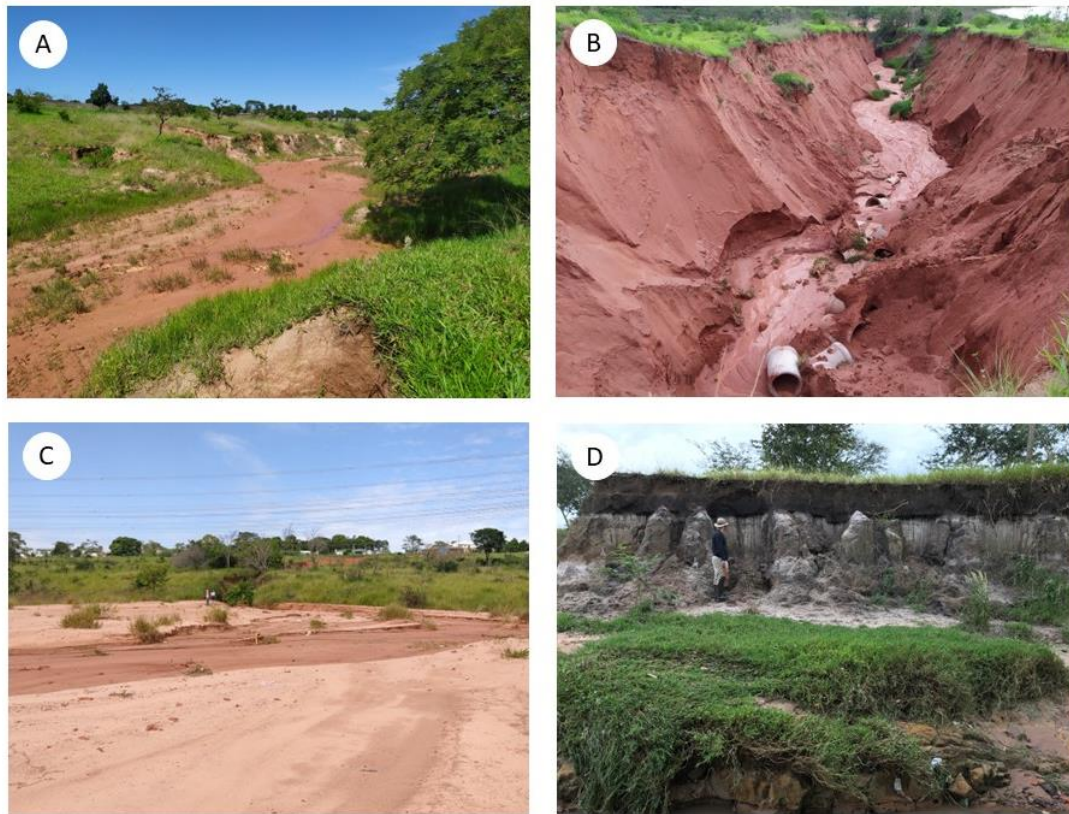
Figure 12. A) Erosion process at the valley bottom, where the lowering of the channel upstream and the silting and drying of wetlands downstream occur; B) ravine at Quinta da Bela Olinda, developed due to problems in stormwater sewers; C) silted-up area in the region of Quinta da Bela Olinda; D) soil profile, indicating lowering of the channel and drying of wetlands.

Figure 3. A) Erosion process at the valley bottom, where the lowering of the channel upstream and the silting and drying of wetlands downstream occur; B) ravine at Quinta da Bela Olinda, developed due to problems in stormwater sewers; C) silted-up area in the region of Quinta da Bela Olinda; D) soil profile, indicating lowering of the channel and drying of wetlands.

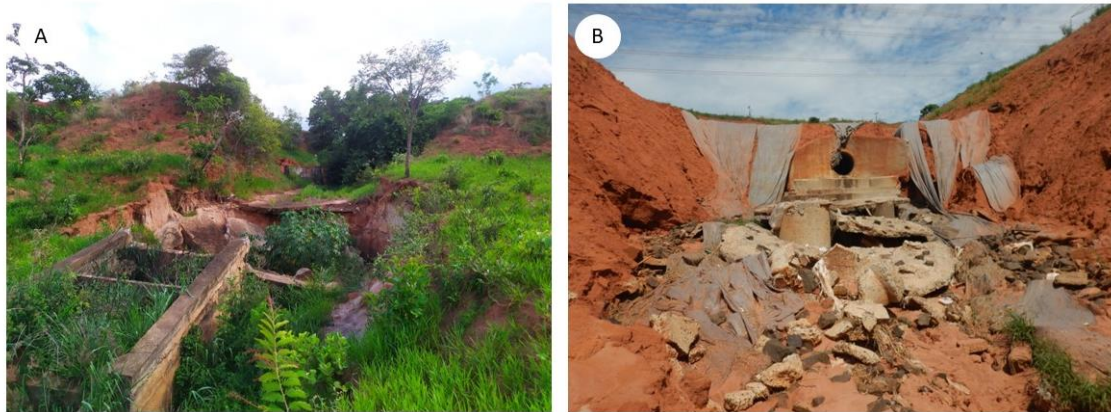
Figure 13. Erosion containment structures damaged by lack of maintenance or sizing errors: a) Jardim Grama; and b) Quinta da Bela Olinda.

Figure 4. Erosion containment structures damaged by lack of maintenance or sizing errors: a) Jardim Grama; and b) Quinta da Bela Olinda.

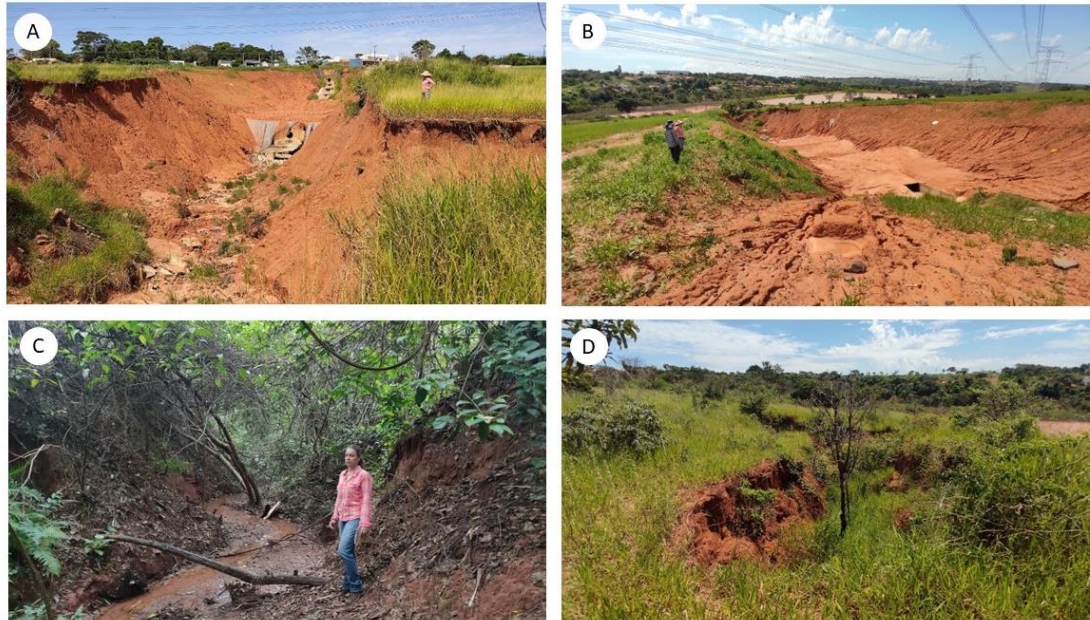
Figure 19. a) top view of ravine 5, the implemented works already have some of their functionality damaged, b) top view of ravine 5, where it is possible to observe grooves demonstrating the concentration of surface runoff into the ravine channel; c) gully 1, which shows water flow in the channel and vegetation composed of trees in the surroundings; d) ravine 2, with pasture and small trees inside and around the channel, indicating stability of the feature.

Figure 7: a) top view of ravine 5, the implemented works already have some of their functionality damaged, b) top view of ravine 5, where it is possible to observe grooves demonstrating the concentration of surface runoff into the ravine channel; c) gully 1, which shows water flow in the channel and vegetation composed of trees in the surroundings; d) ravine 2, with pasture and small trees inside and around the channel, indicating stability of the feature.

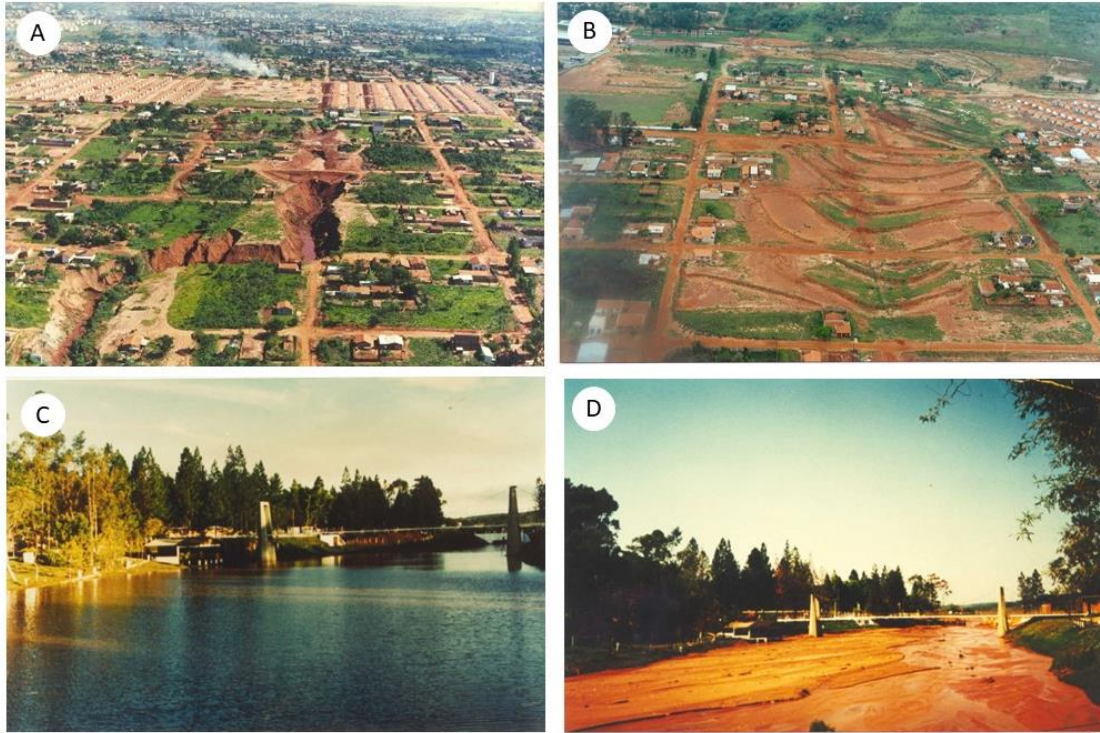
Figure 20. A) gully of Parque Bauru in 1993; B) emergency works to mitigate erosion; C) Bauru Country Club dam before the development of erosion; D) silting of the Bauru Country Club dam due to the development of erosion upstream in 1993 (Photos: Nariaqui Cavaguti).

Figure 8. A) gully of Parque Bauru in 1993; B) emergency works to mitigate erosion; C) Bauru Country Club dam before the development of erosion; D) silting of the Bauru Country Club dam due to the development of erosion upstream in 1993 (Photos: Nariaqui Cavaguti).

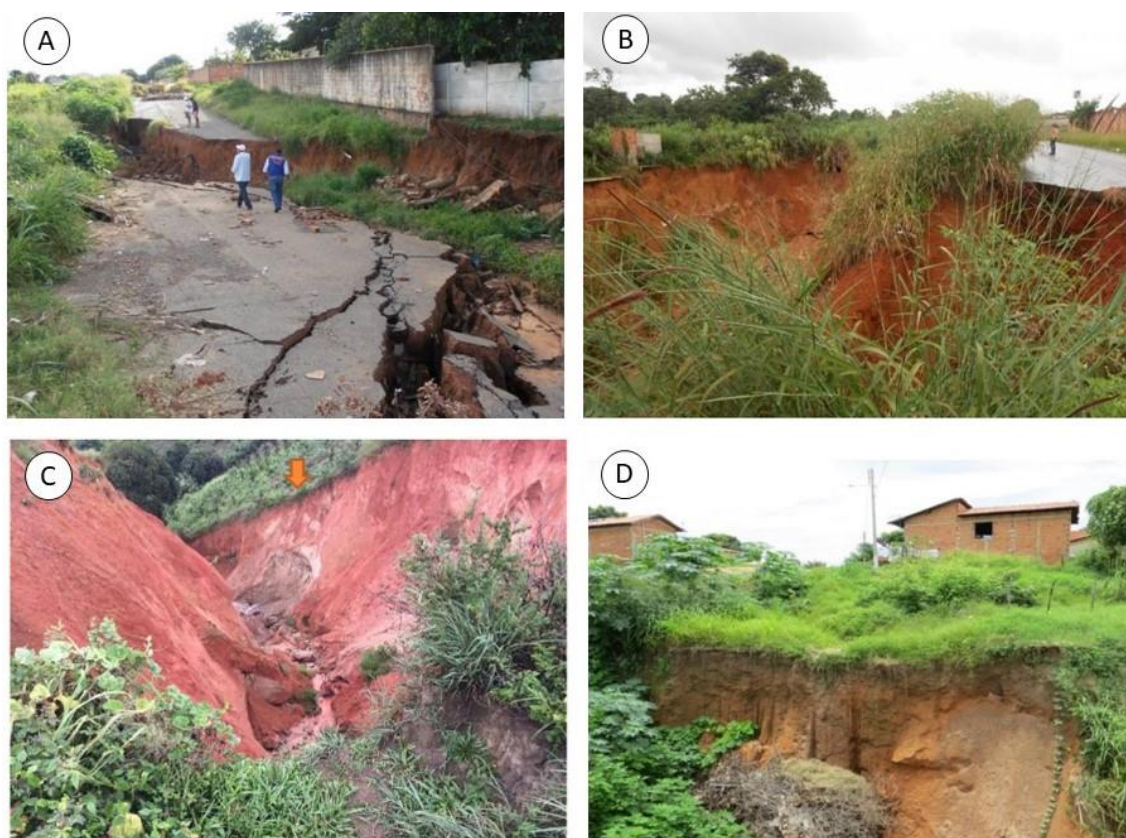
Figure 4. Examples of gullies and ravines in Brazil. A and B: Gully located at Rua 14-E, municipality of Aparecida de Goiânia, state of Goiás (Cardoso 2013); C: Unstable areas with imminent risk of landslide. Santana do Mundaú, state of Alagoas (Da Silva 2018); D: Ravine under development, 3 meters from residences, municipality of Timon, state of Maranhão (De Oliveira Filho and Dos Santos 2014) (Source: S2ID system reports).

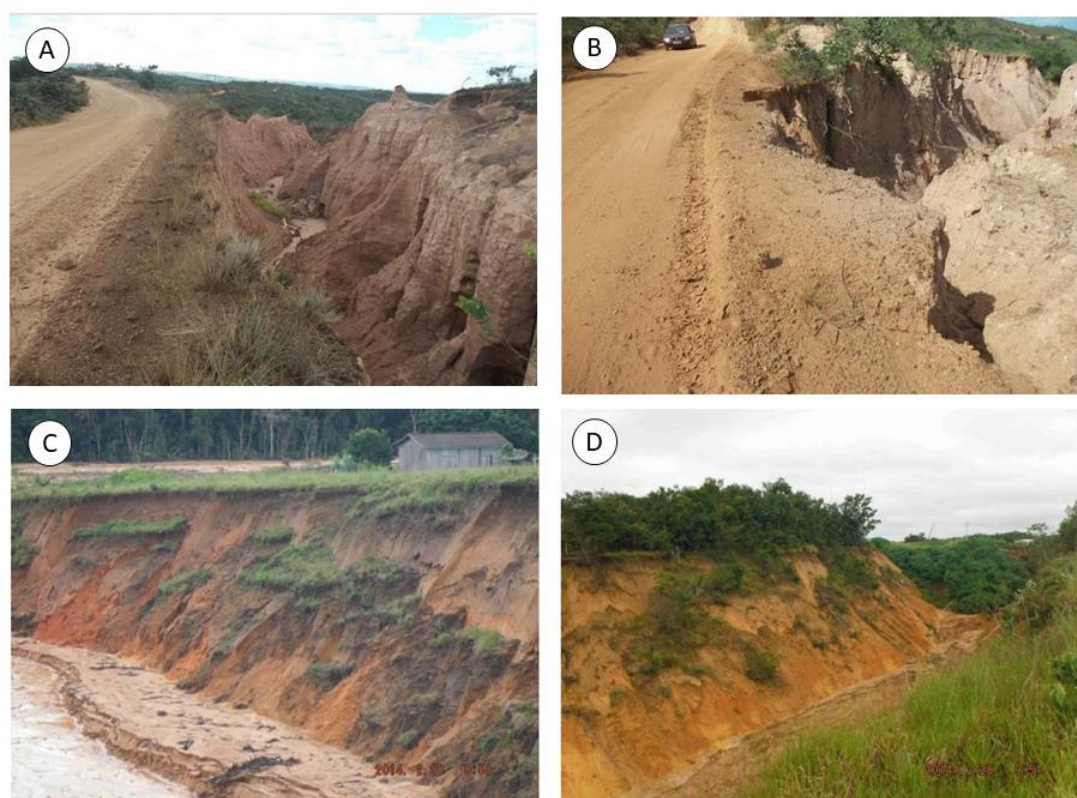
Figure 5. Examples of gullies and ravines in Brazil. A and B: Rural roads affected by erosion in Tiros, Minas Gerais state (Longe 2014); C and D: residence close to erosion and the Cascalheira stream where water is collected for public supply, municipality of Comodoro, state of Mato Grosso (dos Santos 2014) (Source: S2ID system reports).

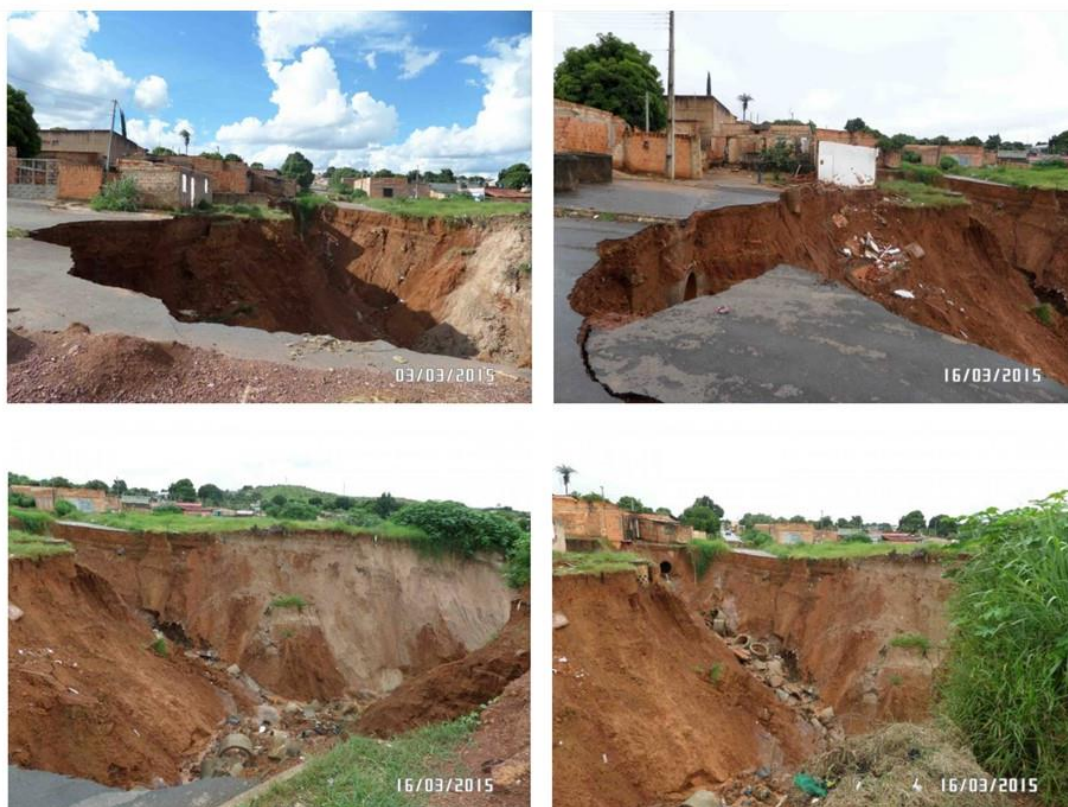
Figure 6. Destruction of public structures and residences in the municipality of Novo Gama, state of Goiás (Pimenta 2015). (Source: S2ID system reports).

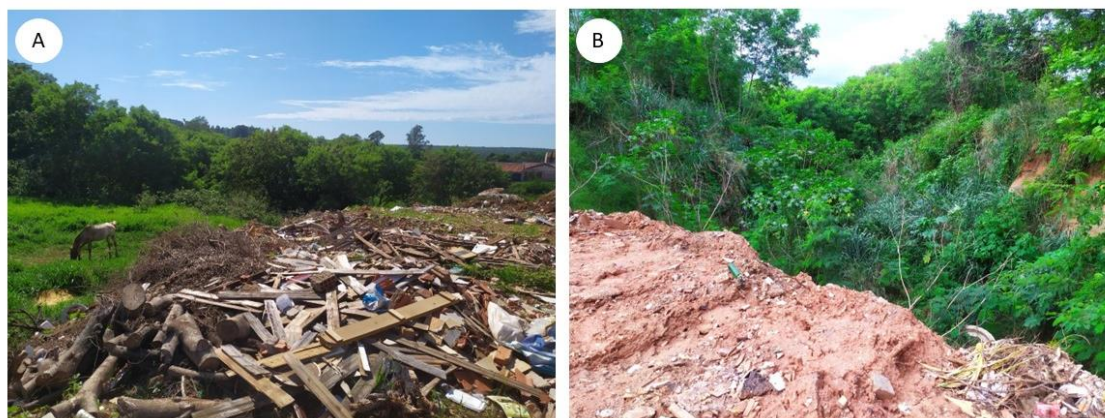
Figure 5. a) Use of the area affected by erosion for urban waste disposal (pruning, organic and construction waste); b) waste disposal in the gully channel in Vila Ipiranga.
