Troia 1987–2012: Grabungen und Forschungen I

Forschungsgeschichte, Methoden
und Landschaft

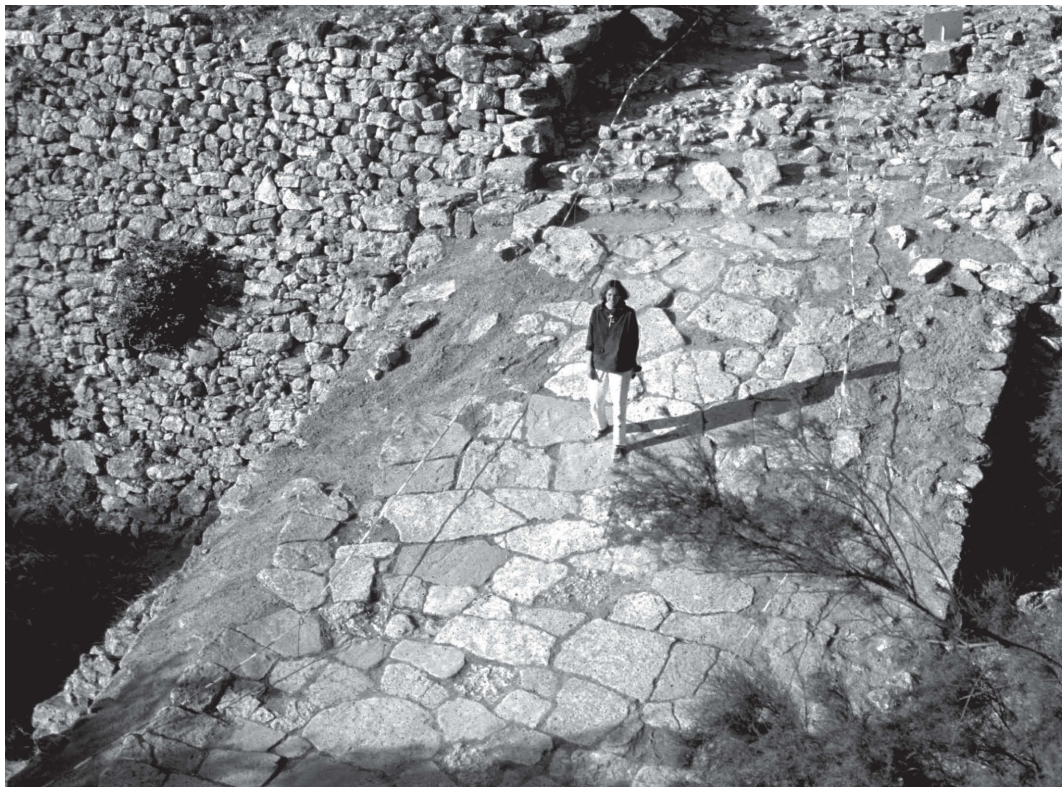
Fig. 1
The condition of the
Troy II Ramp at Gate
FM in 1992, before
stabilization.
BW 92/101-10

The first section of the path, a bridge in the area D6/7, removed the foot traffic from the Troy II Ramp in 1992; as soon as it was finished, work began on the stabilization of the Ramp (more on this under Sections 3 and 4 following). Detailed documentation of the Ramp at a scale of 1:20 had been completed in 1990 and 1991 by a very patient Azer Arazlı, who endured the constant passage at her elbow of curious tourists while doing her meticulous drawing. The lower part of the Ramp disappeared under the profile, representing the entire stratigraphy of Troy VII down to Troy II. At this bottleneck for the tourist traffic it was necessary to build a masonry retaining wall to hold back the fill that carried the path. Before constructing this causeway-like element in 1993, sub-surface drainage was installed to prevent pools of water collecting at the bottom of the Ramp. As will be noted below in this section, this was not the only place at Troy where drainage was a major issue. Also in 1993 a stair was added to connect the »causeway« described immediately above with the Troy VII levels atop the hillock. Once this stair was in place the eroded stepped ramp in area B6 became redundant and a treatment of the slope along with Megaron VIA could be studied (more on this in Section 4 following). Finally, in 1996 the time had come to deal with the visual confusion of the masonry »causeway.« The solution was to extend the wooden pathway with a great cantilever over the stone element; this design (concept – including rope fence – by the author, development and construction supervision by Craig Jolly) simultaneously solved two problems. First, the confusing stone retaining wall »disappeared« under the cantilevered platform; second, the widening allowed a convenient place to view and photograph the Ramp, or for groups of visitors to cluster for a short narration about the Ramp (Fig. 2).

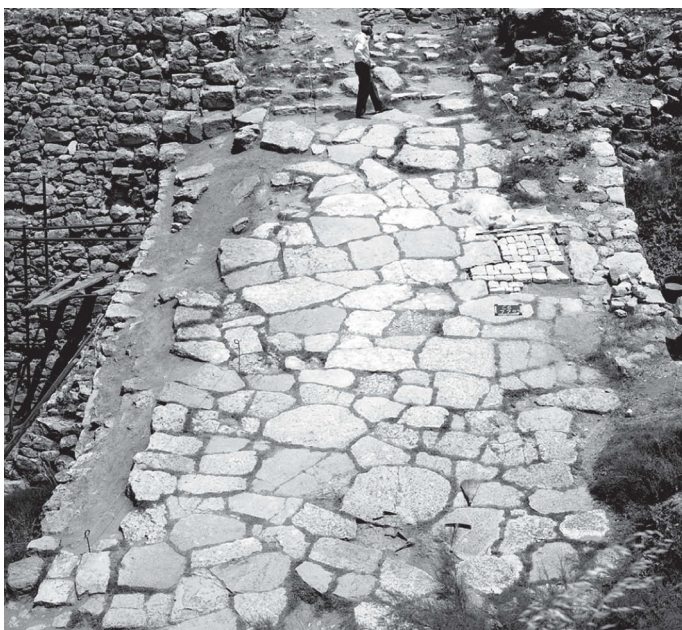
Fig. 2
The Troy II Ramp during
conservation work
in 1992.
BW 92/101–7

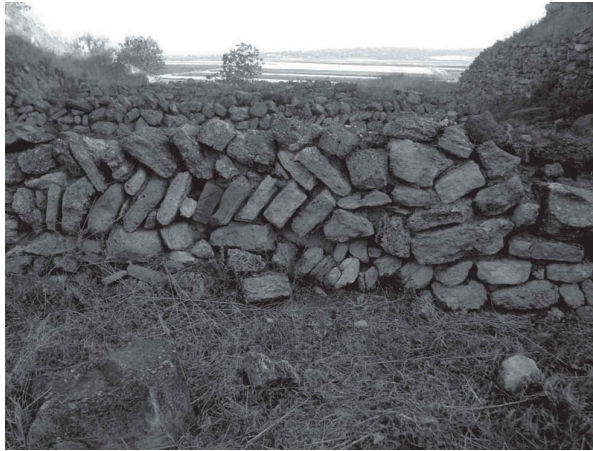
Fig. 3
A top treatment of a Troy I wall in the northern Schliemann trench, with the tile separation joint (2008); historic photos were used to re-create the typical »herringbone« technique. Provided by the author.

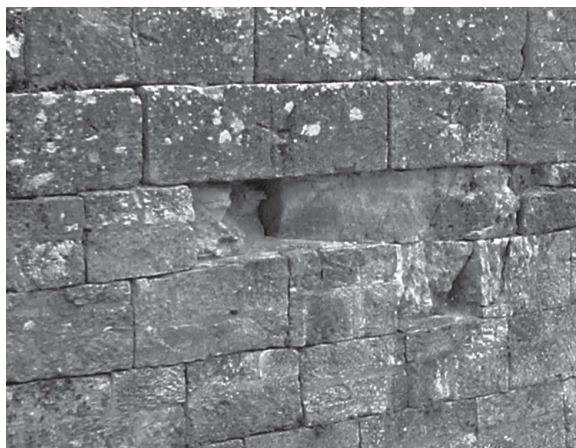
Fig. 5
A section of Wall IX N (Athena Temenos) near the Troy VI Northeast Bastion, showing the saw-cut mosaic infill; the »windows« show the original fabric behind; note mason's marks in original face blocks. Provided by the author.

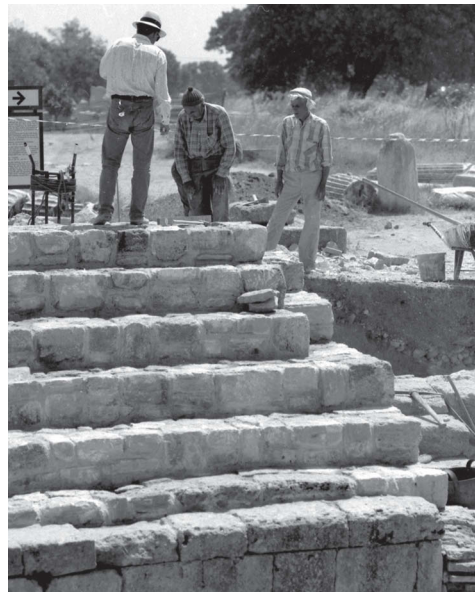
Fig. 7
The Odeion during
stabilization in 1993.
BW 93/076– 30 to 31.

At Troy, the small Roman Odeion was already being used for concerts and performances, despite its dilapidated condition. It required both immediate and necessary stabilization, and a slightly higher level of intervention than normally used at Troy. The work of stabilizing the cavea (seating area) and stage building began in 1992 (Fig. 7) and was finished in 1998 (Fig. 8), while excavations occurred at the same time. The pre-Roman levels of the excavation were reached late in the 1995 season. Since 1998 the consolidant used on the remains of the *opus mixtum* wall between the orchestra and the stage has lost its effectiveness (and we have concluded already that using consolidants is not the best approach) – therefore in the near future another approach will be attempted. The formula for the

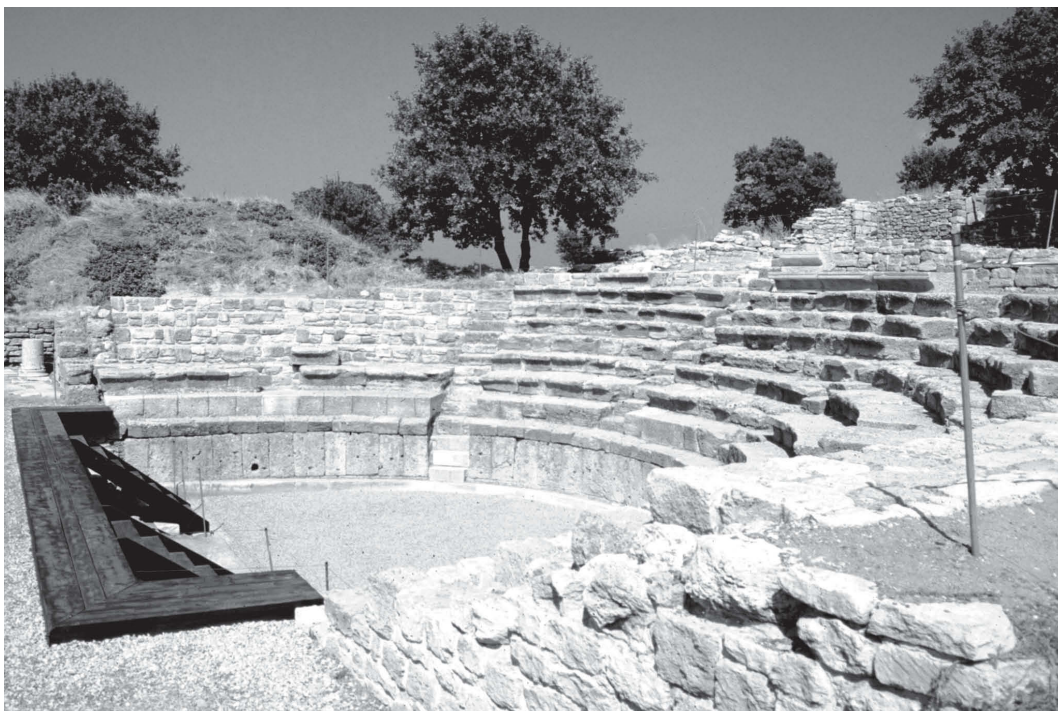
Fig. 8
The restored Odeion
in 1998. Troia Projekt,
Tübingen.

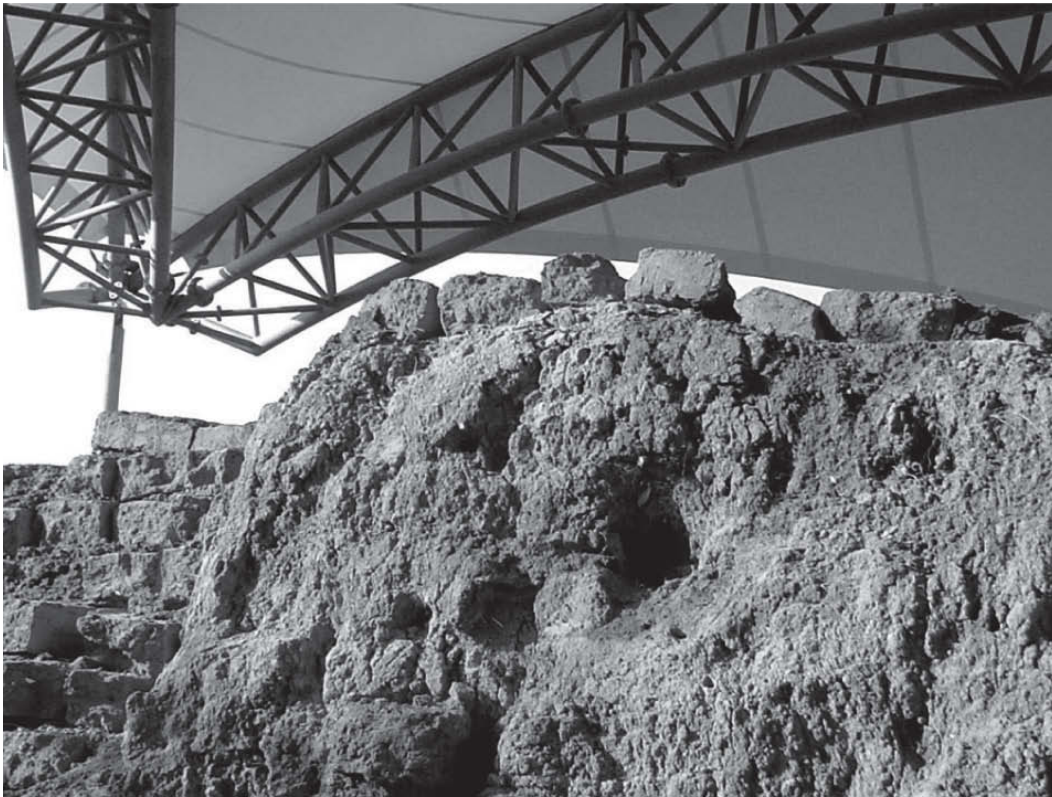
Fig. 9
Under the G6 roof;
the original Troy II mud-
bricks are protected
with a layer of specially
created »burned«
brick – the formula is
included in the Appen-
dices. Provided by
the author.

erected; the structure was finished in 2003. The roof was designed by Björn Rimner, under supervision from his thesis advisors at the University of Stuttgart.²² In accordance with the *Venice Charter*, the roof is clearly of its own time and would never be confused with any original feature; it is also expressive of its primary purpose (Fig. 9). The 2009 Site Management Masterplan calls for all additional roof structures to be a »theme and variation« on this construction type, which will then become associated (it is hoped) with a »Troy« image.
